DOT/FAA/CT-93/1

Vertical Drop Test of a Metro III Aircraft

June 1993

Final Report

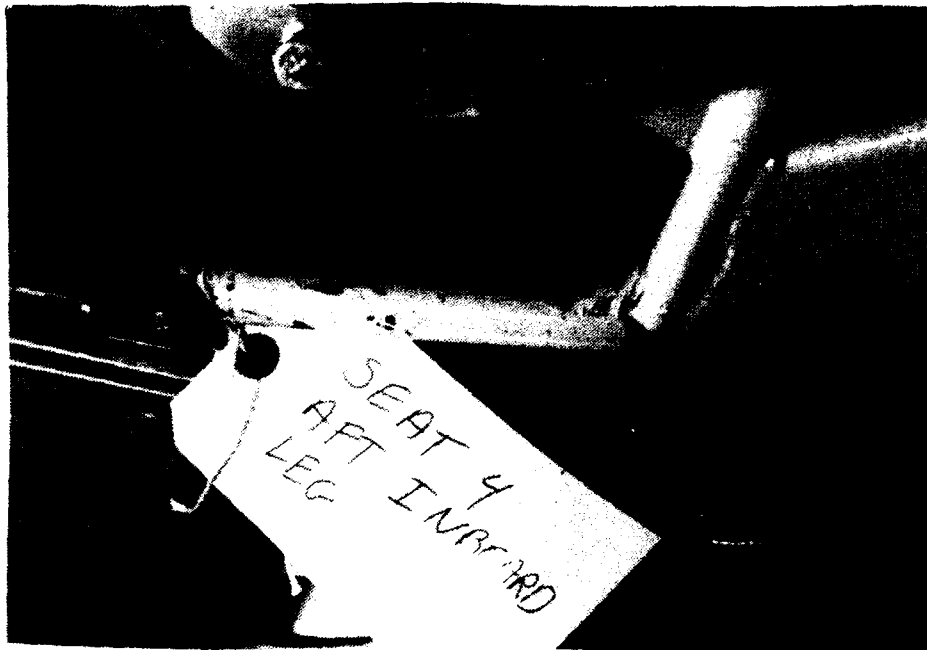
FIGURE 24. POST TEST SEAT 4, INBOARD AFT LEG

Figures 23 and 24 show an overall view and the inboard aft leg of seat number 4 after the test, while figure 25 shows the seat track.

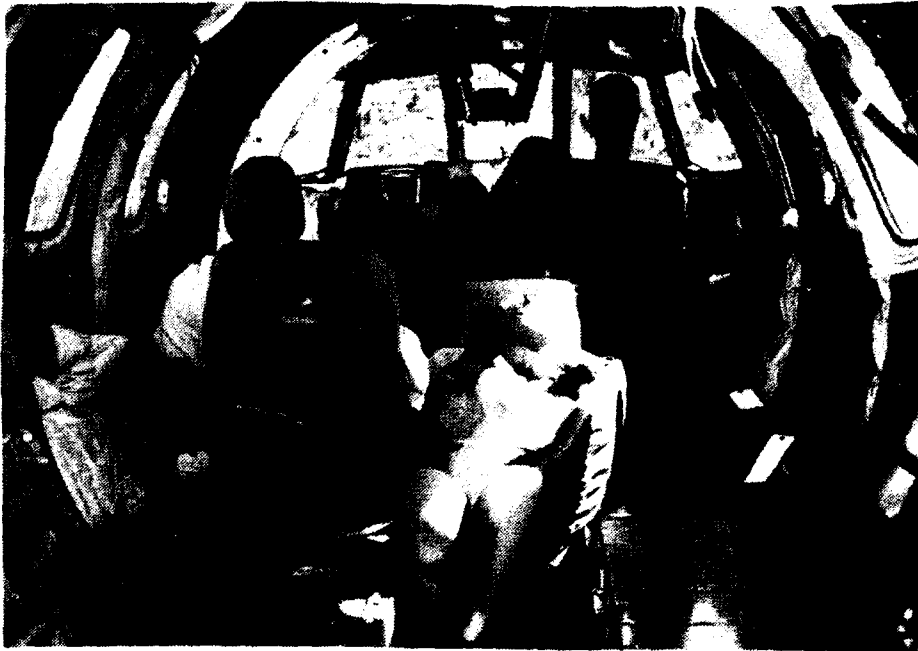
FIGURE 26. POST TEST SEAT 5

Figure 26 is a post-test view of seat 5. Figures 27 and 28 show the inboard and outboard aft legs respectively, and figure 29 shows the damage to the seat track.

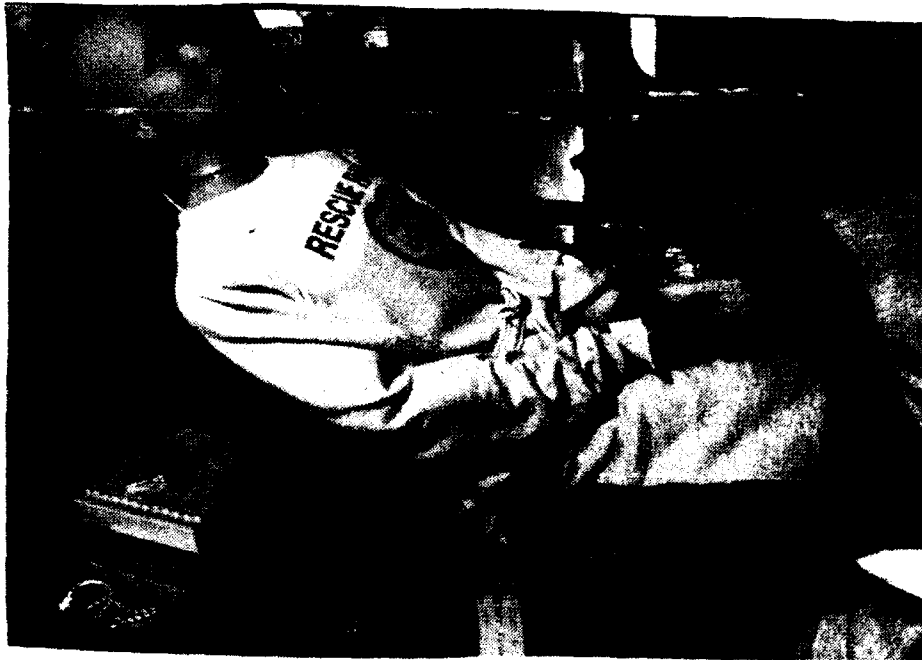
FIGURE 30. POST TEST 6

Figure 30 is a view of seat 6 after the test. Figure 31 shows the damage to the inboard aft leg, while figure 32 is a view of the seat track.

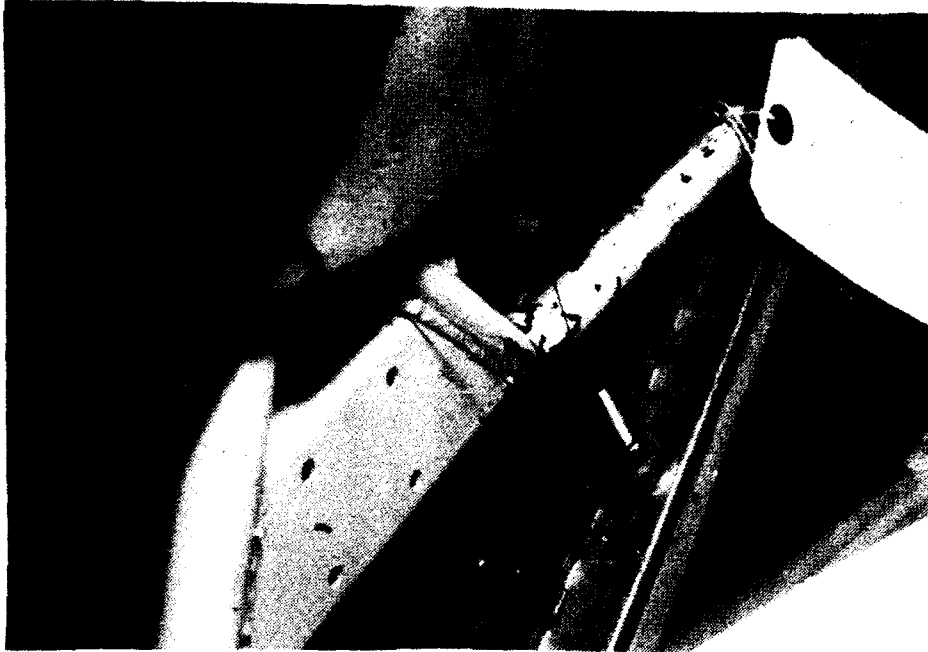
FIGURE 34. POST TEST SEAT 7, INBOARD AFT LEG

Figure 33 shows seat 6 (on the left) and seat 7. Figure 34 shows the damage to the inboard aft leg of seat 7, and figure 35 shows the damage to the seat track under seat 7.

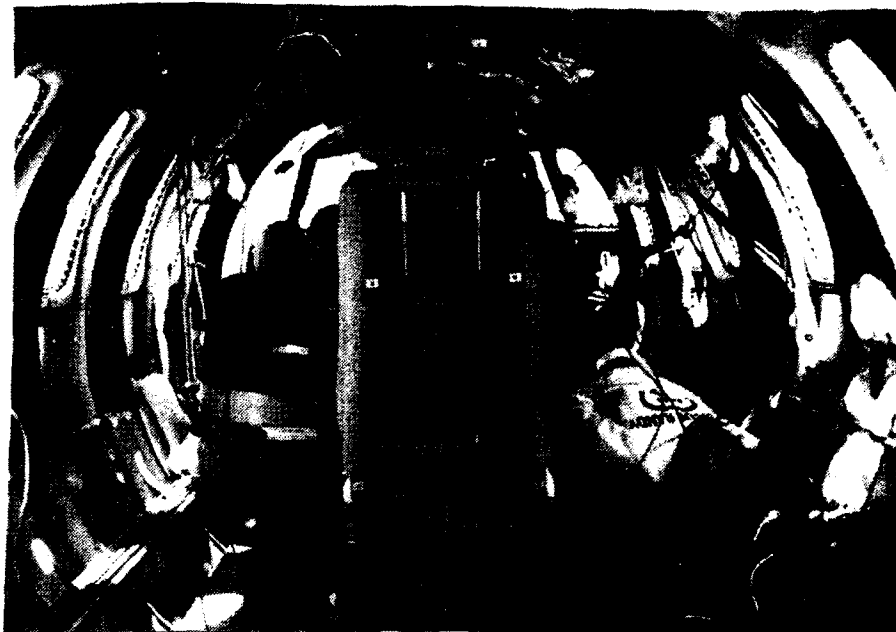
FIGURE 36. POST TEST SEAT 8, CAMI SEAT

Figure 36 is the rear view of the CAMI seat (seat 8) after the test. Figure 37 shows a closeup of the seat pan after the test; notice the deflection of the energy absorbing mechanism caused by the impact.

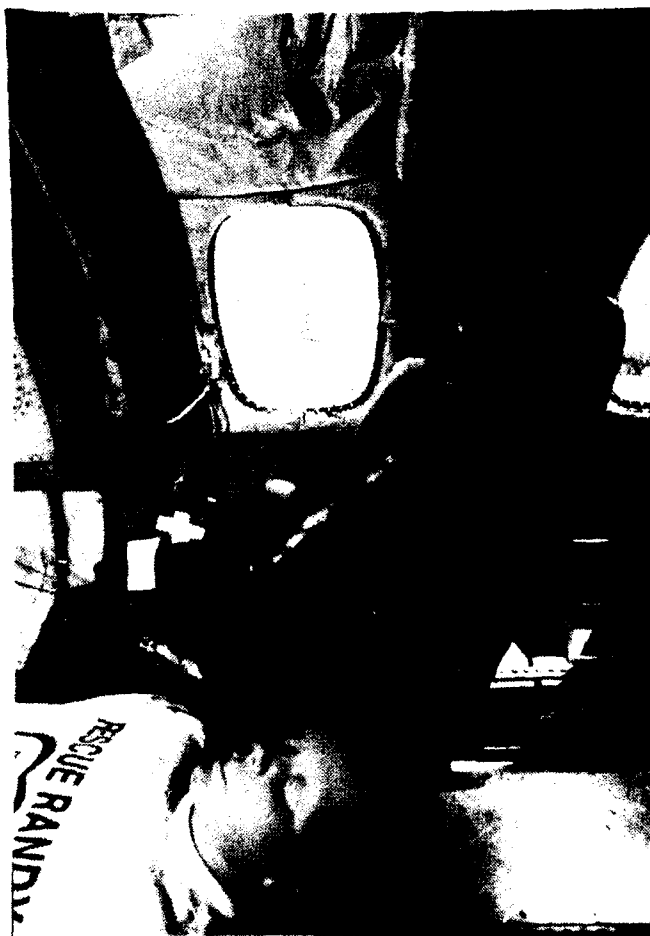
FIGURE 43. POST TEST SEAT 12

Figure 43 shows seat 12 after the test. Figure 44 shows the resulting damage on the inboard aft leg of seat 12.

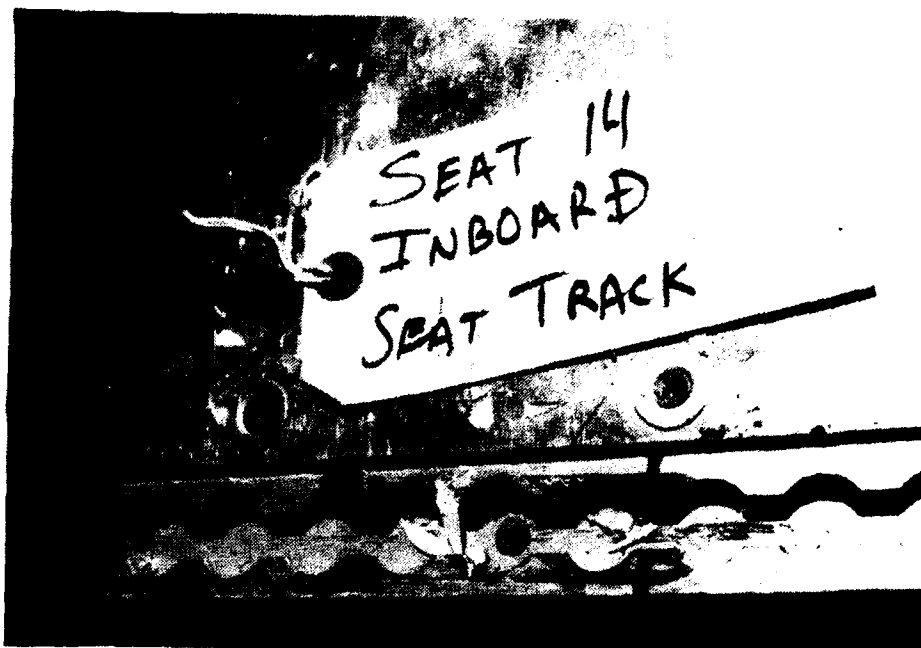
FIGURE 48. POST TEST SEAT TRACK, SEAT 14

Figure 47 is a post-test rear view of seat 14, while figure 48 is a closeup of the track under seat 14.

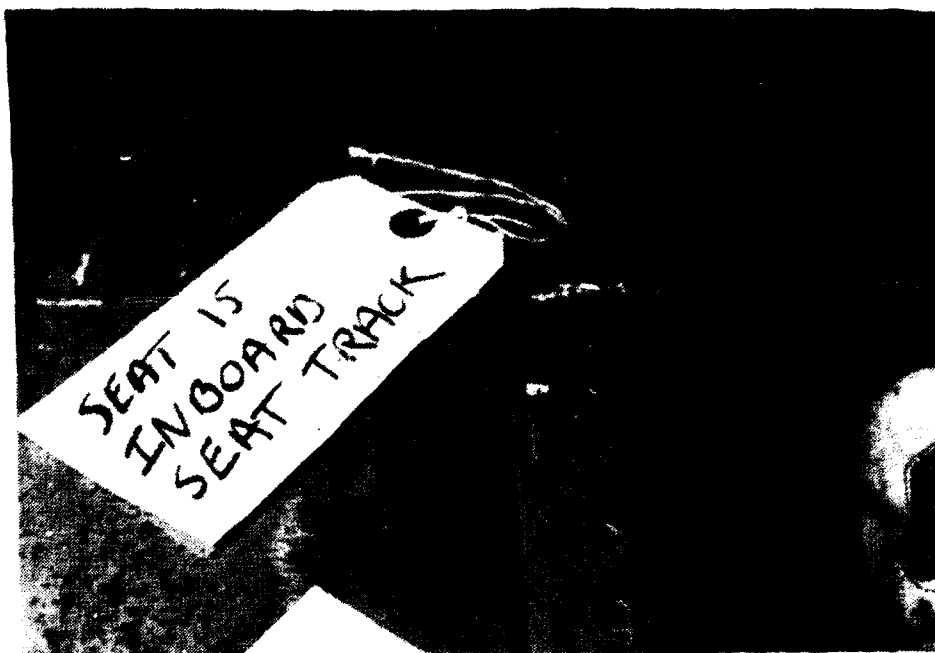
FIGURE 52. POST TEST SEAT TRACK, SEAT 15

The seat track is visible in figure 52.

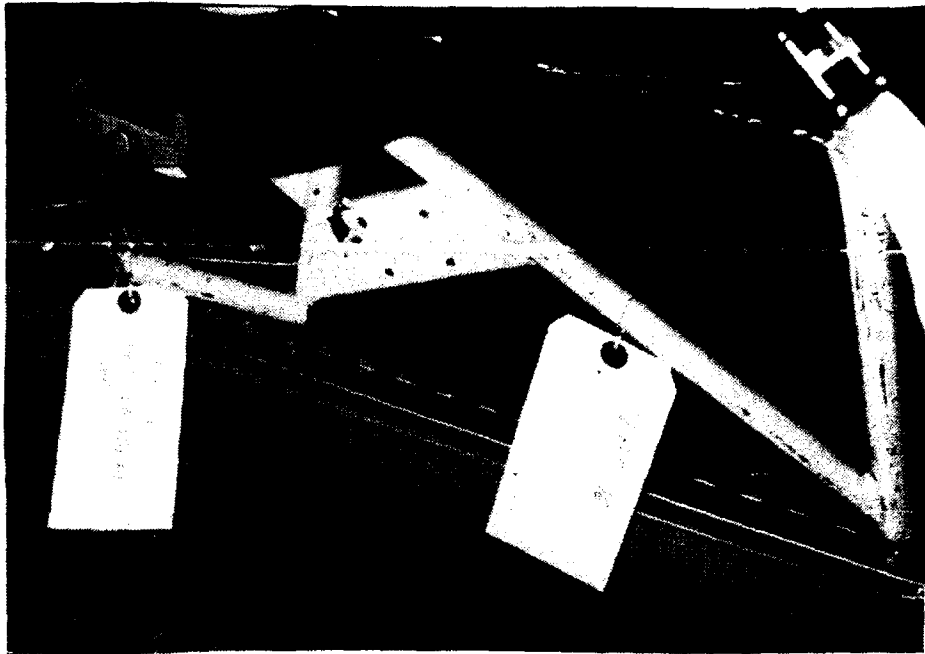
FIGURE 54. POST TEST SEAT 16, INBOARD LEGS

Figure 53 shows the final seat (16), which is rear facing, after the test. Figure 54 is a view of the inboard legs of seat 16, while figure 55 shows the seat track.

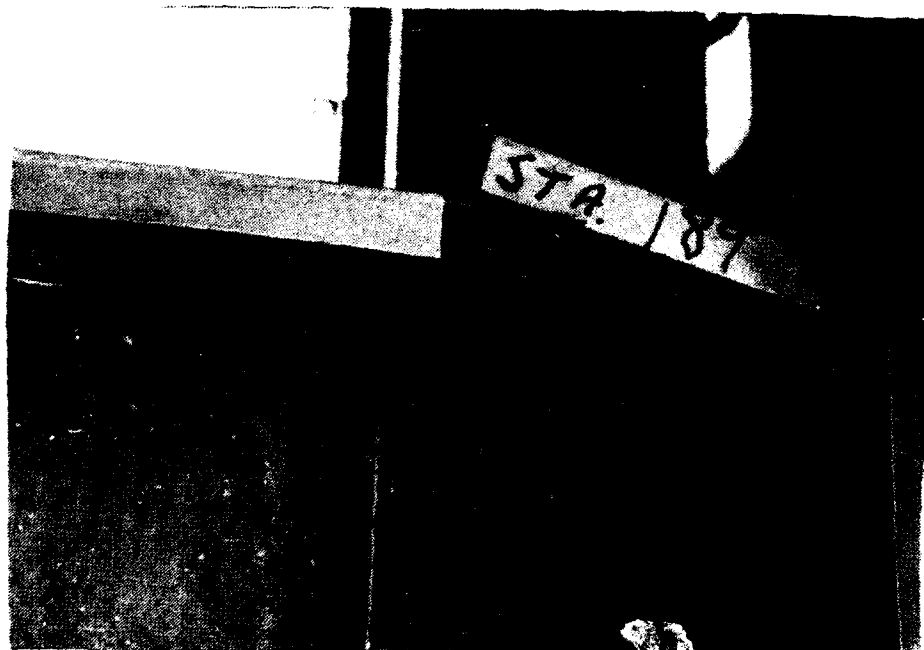
FIGURE 63. POST TEST INTERIOR FUSELAGE, BODY STATION 189

The interior of the fuselage also experienced some damage during the test. Figure 62 shows an example of such damage, occurring at body station 159. Figure 63 shows more structural damage at body station 189. Ceiling damage can be seen in figure 64, while sidewall damage is observed in figure 65.

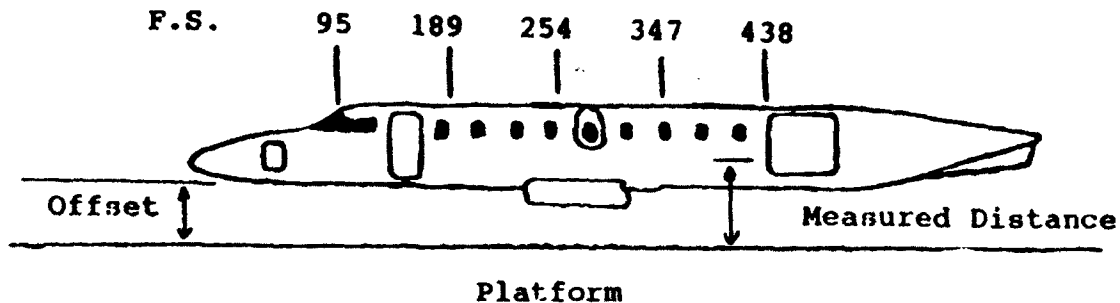
FIGURE 66. FUSELAGE CRUSH MEASUREMENT LOCATIONS

As a result of the test, the fuselage experienced a slight deformation, varying throughout its length. The deformation was calculated by measuring the distance from a set point on the aircraft to the platform, both prior to and after the test. An offset value was used to compensate for the wingbox prior to the test, and the forward lean of the aircraft about the wingbox, after the test. See table 4 and figure 66. No significant crush of the airframe could be determined by film analysis.

F.S.	CRUSH (Avg)	
	LEFT	RIGHT
95	0.88	
189	1.06	
254	1.19	
347	1.41	
438	0.66
